M.A.E.E. Report No. F/187
(Saunders-Roe Report No. FT/15/0/24, Part 3)

June 1955

SAUNDERS-ROE PRINCESS FLYING BOAT G-ALUN

ENGINEERING APPRAISAL

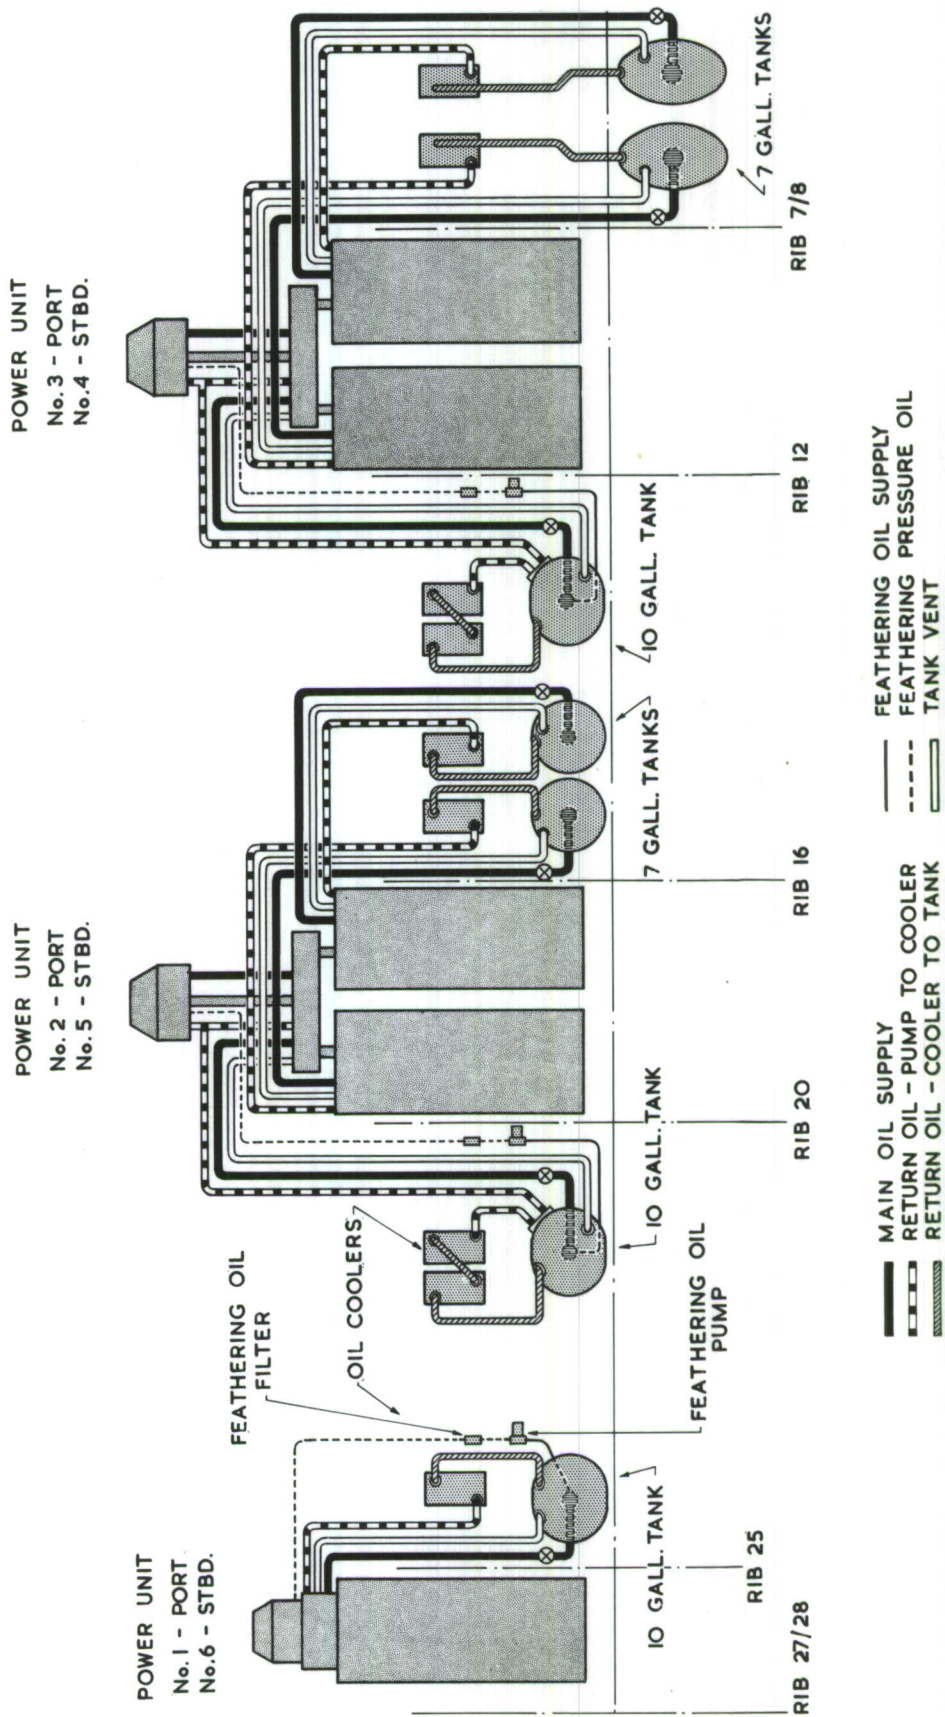
DIAGRAM OF OIL SYSTEM

The four coupled engine transmission systems and the combined single engine systems were satisfactory. The oil systems for the coupled units were not satisfactory. Even under temperate summer conditions it was not possible to warm the oil up to a desirable operating temperature, or to maintain it at a figure above the minimum limit in flight. This over-cooling was mainly due to the low oil circulating rate through the engine, and was aggravated to some extent by air leaks around the cooler shutters. Temporary sealing was fitted to the shutters, and part of the cooler matrix blanked off; this enable flying to continue, but was only a temporary arrangement.

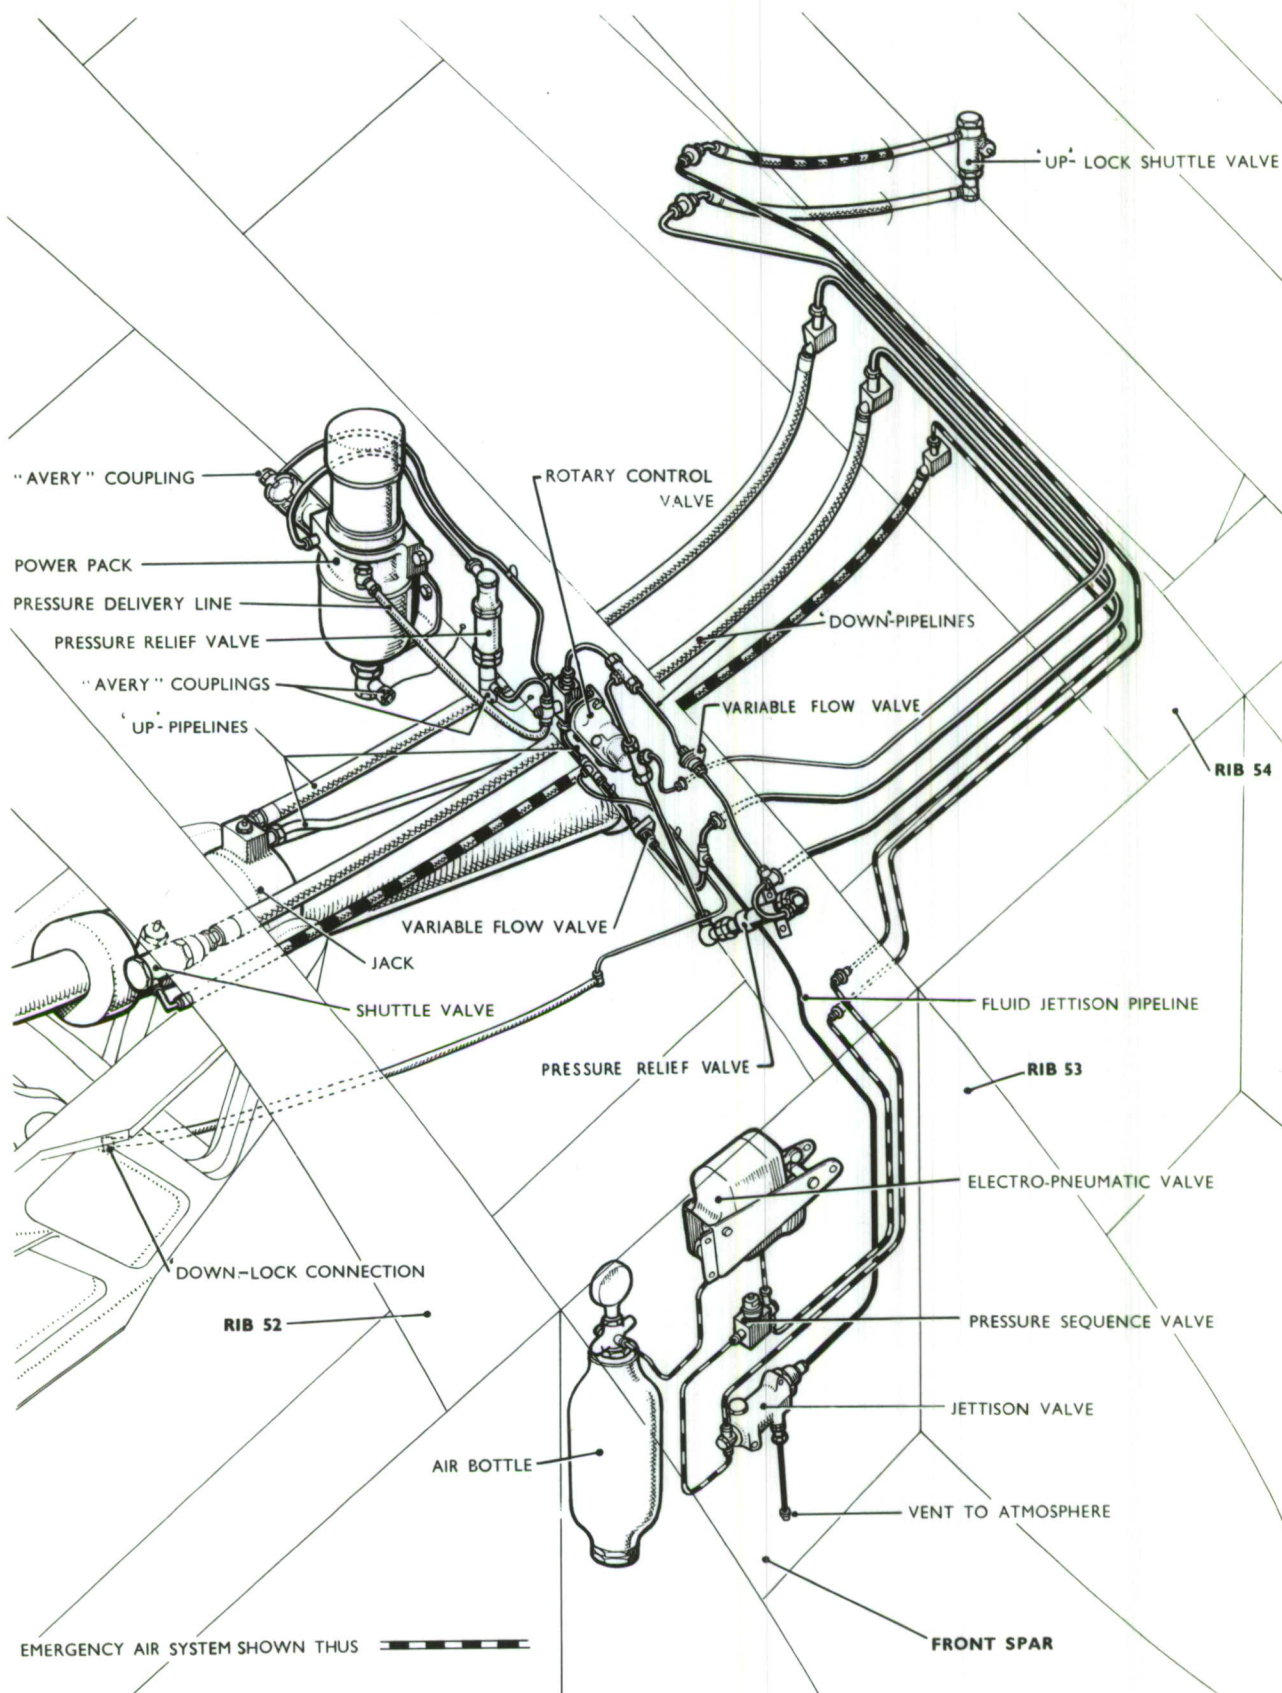
FLOAT HYDRAULIC AND EMERGENCY
AIR SYSTEMS-PORT SIDE

Initially, trouble was experienced with the uplock micro-switches. The type fitted did not allow for sufficient over-swing of the float during retraction, and consequently were crushed. Modified switches and brackets were fitted, which proved completely satisfactory. During early flights, occasional rapid float retractions occurred, taking approximately half the normal time of from 10-12 seconds, and resulting in fractured hydraulic reservoir seals. This was overcome by fitting an additional variable flow and pressure relief valve in the return line from the jack to the rotary control valve.

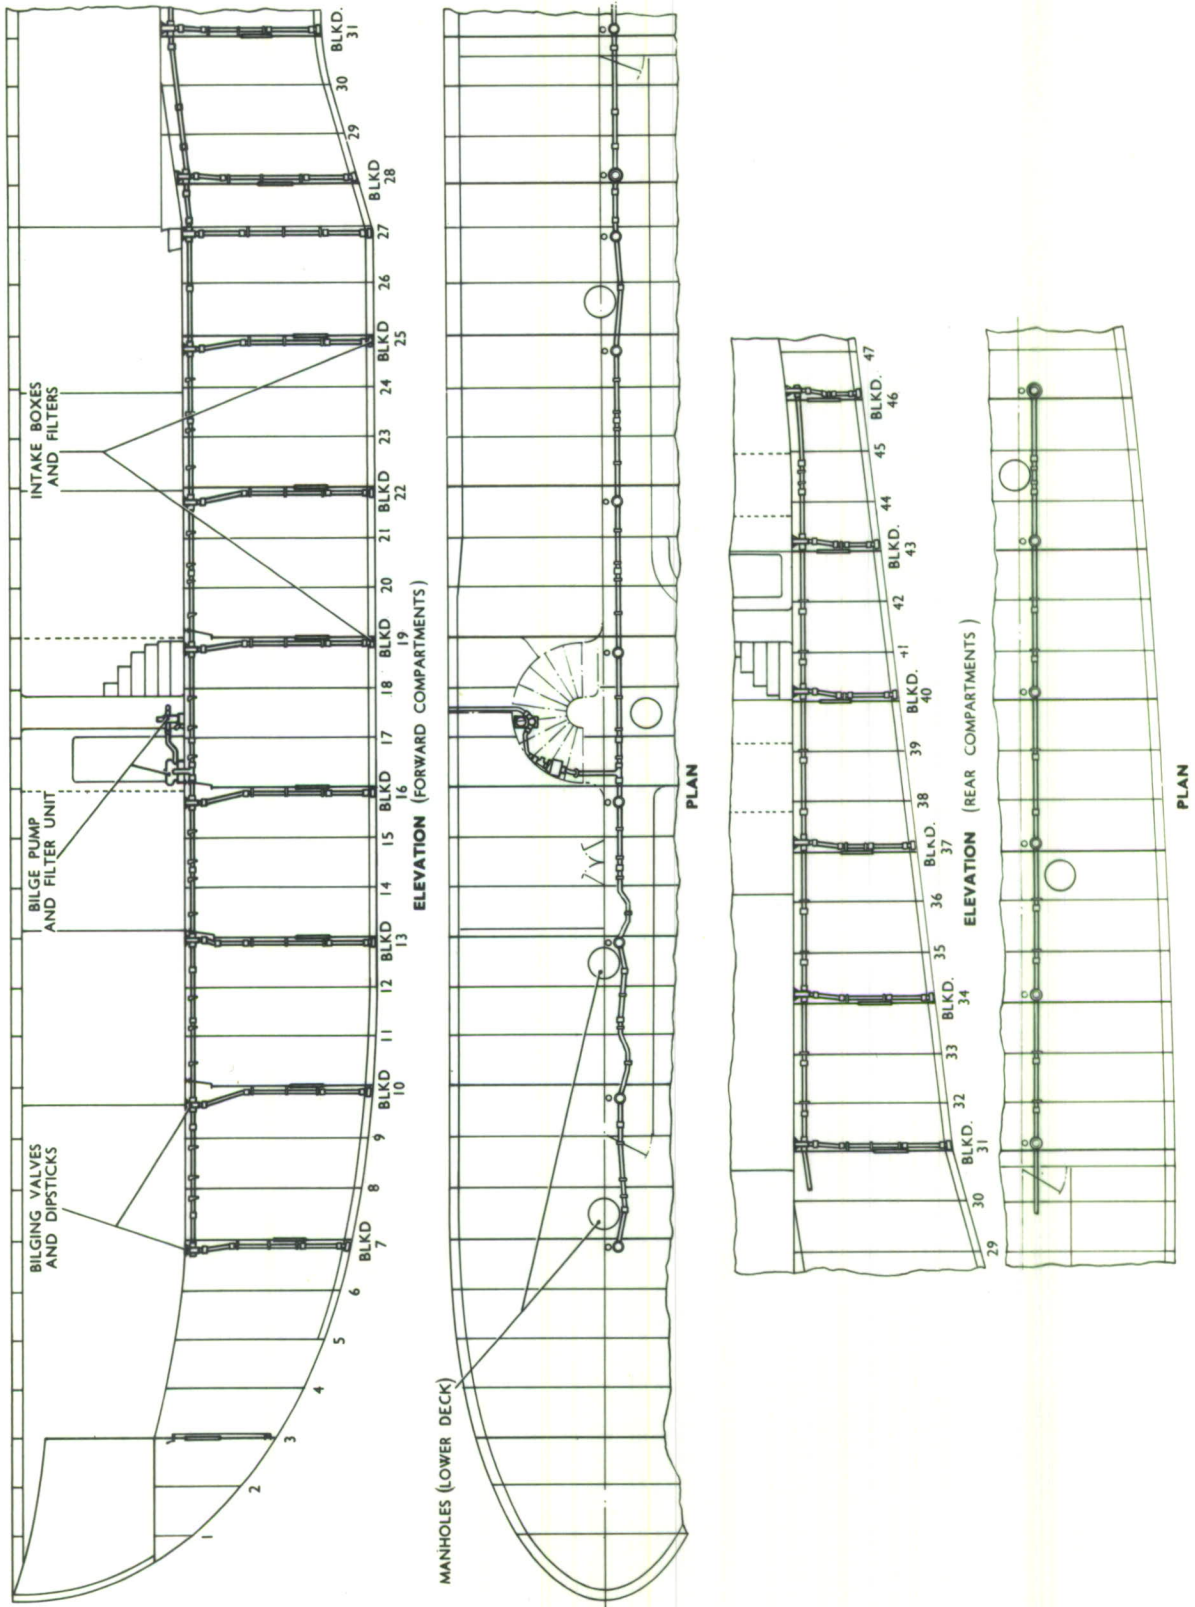
DIAGRAM OF BILGING SYSTEM

The troubles encountered on the main bilge pump were the result of corrosion in the units due to the dissimilar metals in the pump, which was aggravated by the effects of salt water. Fresh water was pumped through the unit, but this did not overcome the electrolytic action of the dissimilar metals.

The rubber sealing rings in the disc valves had to be changed on several occasions. These rings were generally damaged whilst sliding past the main gallery unions. The rings expanded into the gallery as the valve was being opened or closed, and were cut away by the continual action of the valve. This process was aggravated by the effects of salt water on the seats, which perished the rubber. A leak in one valve could render the system unserviceable.

The hose piping used for connections at various points in the system was affected by sea water and replacement was necessary on several occasions.

Improvements should be made to prevent the corrosion which occurred of several components, and hence reduce the amount of maintenance necessary on the installation.
